## Farabaugh Engineering and Testing Inc.

### PERFORMANCE TEST REPORT

WIND DRIVEN RAIN TEST  
(ACROSS VARIOUS VENTS)

ROOF VENTS

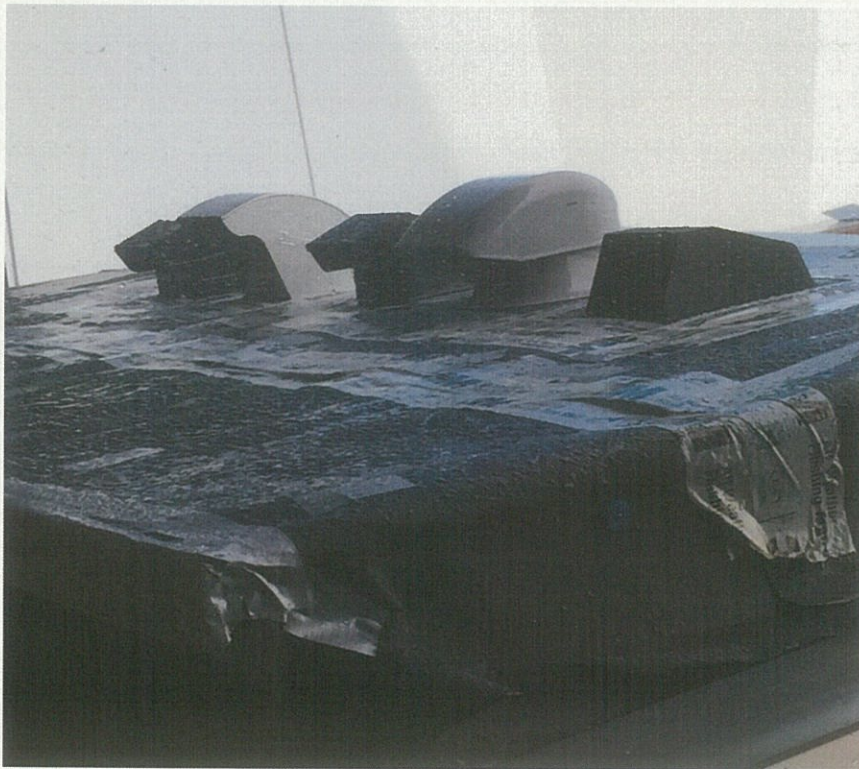
**TOP OF DECKING**

30# felt paper was attached to the top of the plywood. Each roof vent was mounted to the top of a simulated roof system with an exposed 4" diameter exhaust pipe that extended thru the decking to underneath the roof system. All roof vents had their flashing plates nailed down and then the top perimeter was covered with flashing tape so as to stop any water from leaking at flashing plate. The top of each vent was exposed to the wind pressure and water that blew across each specimen.

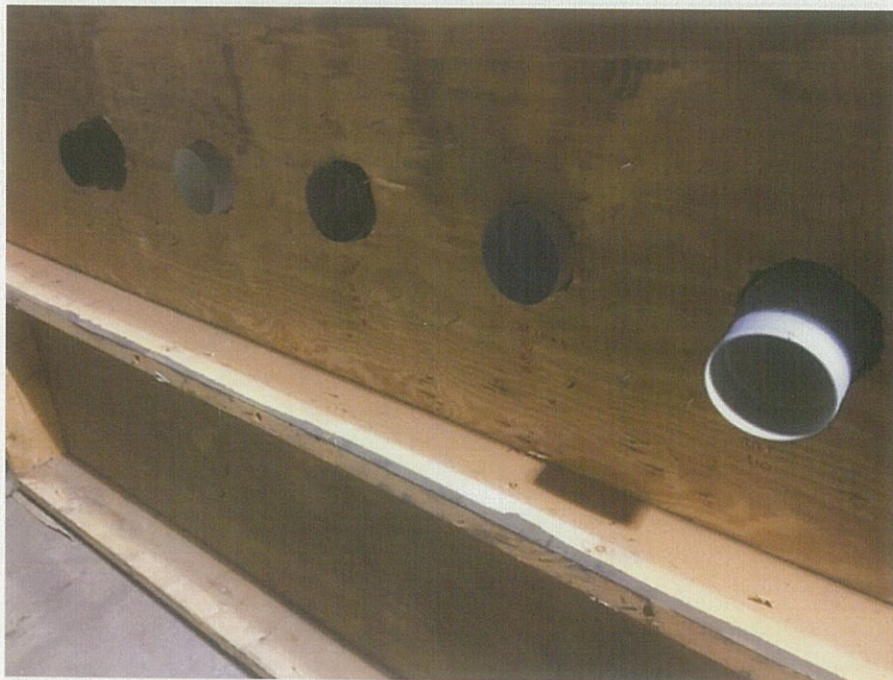
**BELOW DECKING WITH 4" DIAMETER EXTENDED PIPING**

Note: No Leak – No water coming thru 4” extended pipe on underneath of specimen  
 Leak – Water came out of 4” extended pipe underneath.

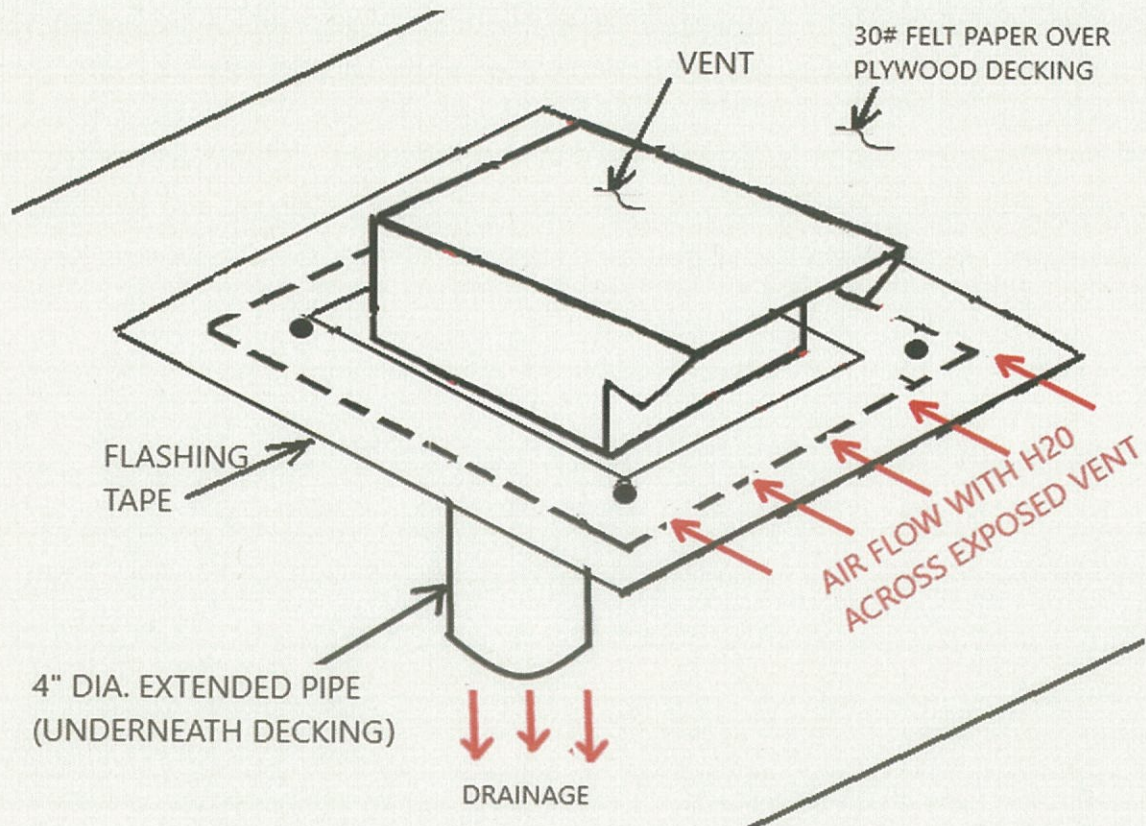
**TEST SPECIMEN SET UP  
(AIR/H2O FLOW ON TOP & DRAINAGE  
UNDERNEATH DECKING)**

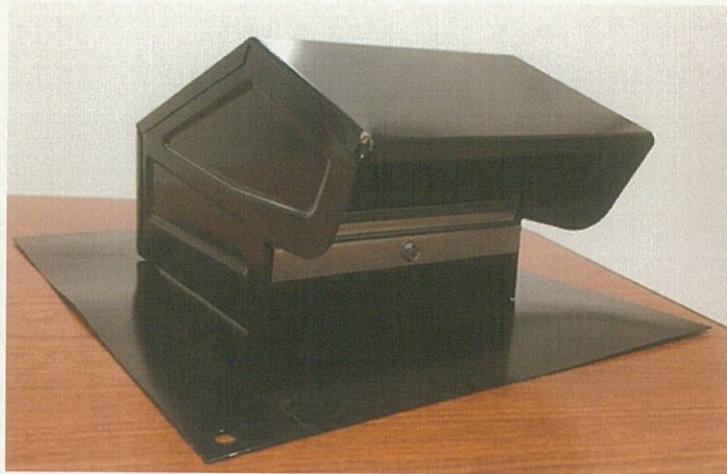
**SPECIMEN #1 - BROAN**

SPECIMEN # (NAME)	WIND SPEED  (35 mph)	WIND SPEED  (70 mph)	WIND SPEED  (90 mph)	WIND SPEED  (110 mph)	COMMENTS
1 (BROAN)	No Leaks	Leak	Leak	Leak & Rattled	While testing at 110 mph the flap rattled and specimen leaked
2 (DRYERJACK)	Leak	Leak	Leak	Leak	
3 (ABC VENT)	No Leaks	Leak	Leak	Leak & Rattled	While testing at 110 mph the flap rattled and specimen leaked
4A-Alum. (B.D. VENT)	No Leaks	No Leaks	No Leaks	Leak	
4B-Steel (B.D. VENT)	No Leaks	No Leaks	No Leaks	No Leaks	
5 (DURAFLO)	Leak	Leak	Leak	Leak

SPECIMEN # / NAME	DIMENSIONS	MATERIAL
#1 - BROAN	5-1/4" W. X 8-1/4" LENGTH X 4-3/8" HT.	STEEL
#2 - DRYER JACK	6-3/8" W. X 9-1/4" LENGTH X 6-3/4" HT.	STEEL
#3 - ABC VENT	5-1/2" W. X 8-1/4" LENGTH X 4-3/8" HT.	STEEL
#4A & 4B - B.D. VENT (ALUM. OR STEEL FLAP)	7-1/4" W. X 10-1/4" LENGTH X 5-7/8" HT.	PLASTIC HOOD
#5 - DURAFLO	5-3/4" W. X 7-3/4" LENGTH X 3-1/4" HT.	PLASTIC

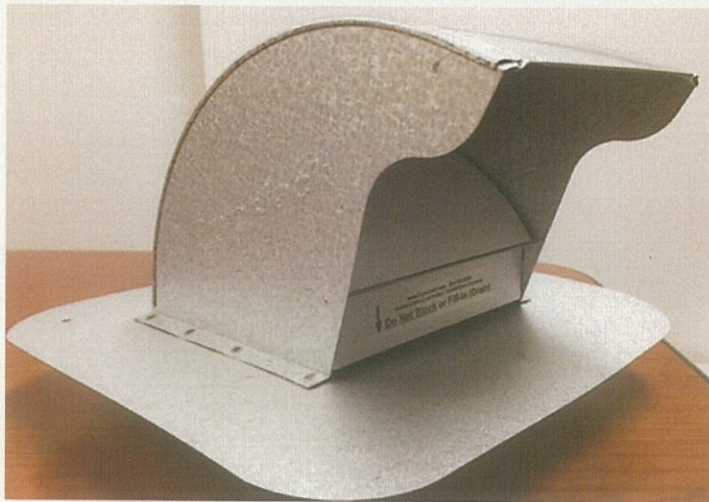
**SPECIMEN #2 – DRYERJACK**

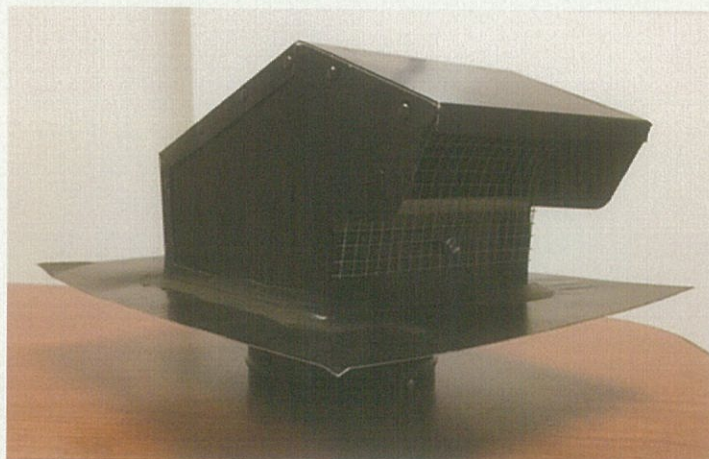
**SPECIMEN #3 – ABC VENT**

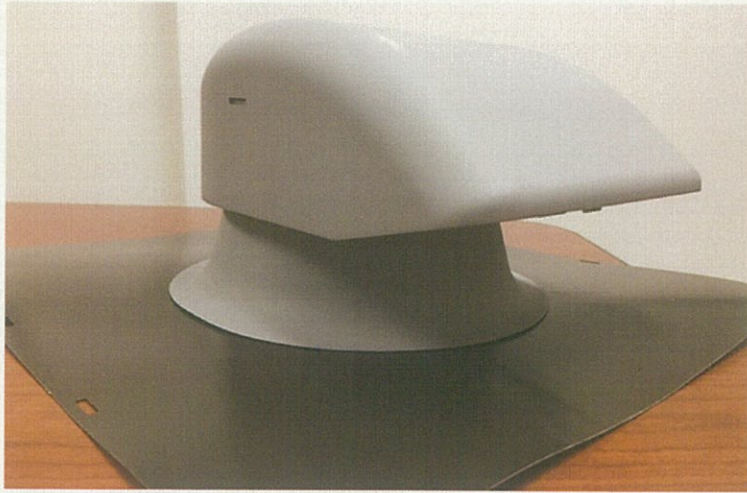
**SPECIMEN #4A & 4B – B.D. VENT (PLASTIC HOOD WITH ALUM  
FLAP OR STEEL FLAP)**

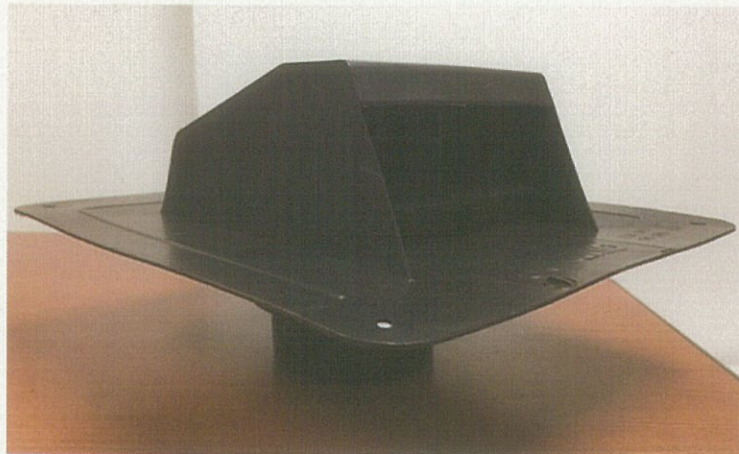
**SPECIMEN #5 - DURAFLO**
